ERICKSON HOUSE AND GARDEN

CONSERVATION PLAN 2015

DONALD LUXTON
AND ASSOCIATES INC

NEILL F. CUMBERBIRCH
ARCHITECT

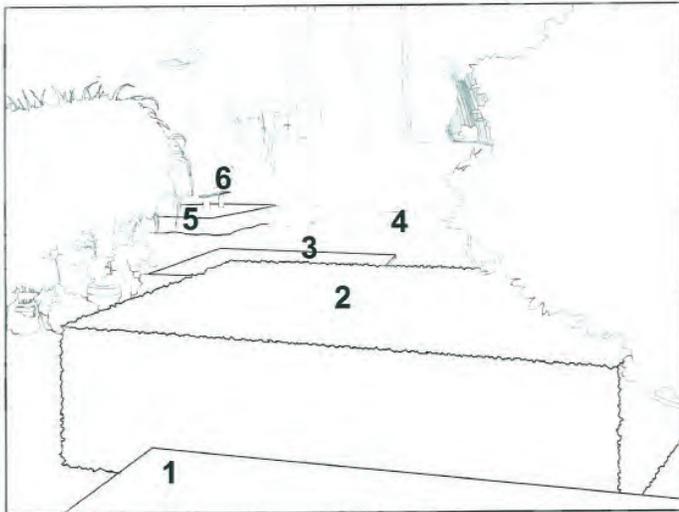
- 1. Cedar Deck
- 2. Japanese Holly
- 3. Granite Moon-Viewing Platform
- 4. Pond
- 5. Moss Terrace
- 6. Marble Bench

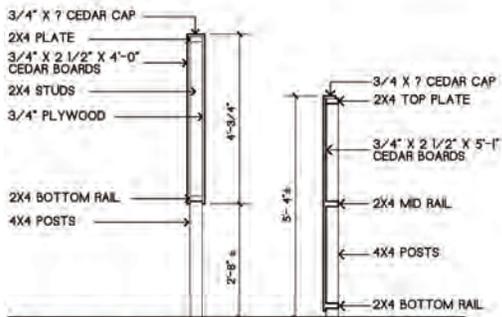
A SECTION THROUGH BAFFLE FENCE & EAST PERIMETER FENCE
1/4"=1'-0"

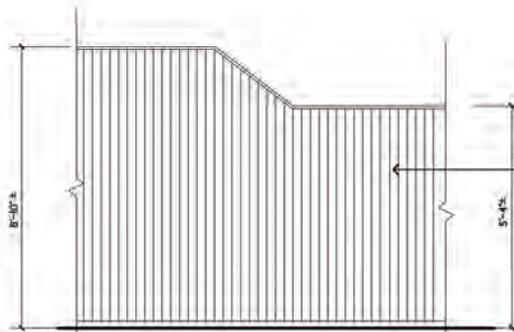
D SECTION THROUGH LOW FENCE

2 1/2" X 3/4" CLEAR CEDAR BOARDS
TREATED WITH 'LifeTime Wood Treatment'
by Valhaloo.
FASTENED WITH GALVANIZED PAIRED NAILS
TO MATCH EXISTING

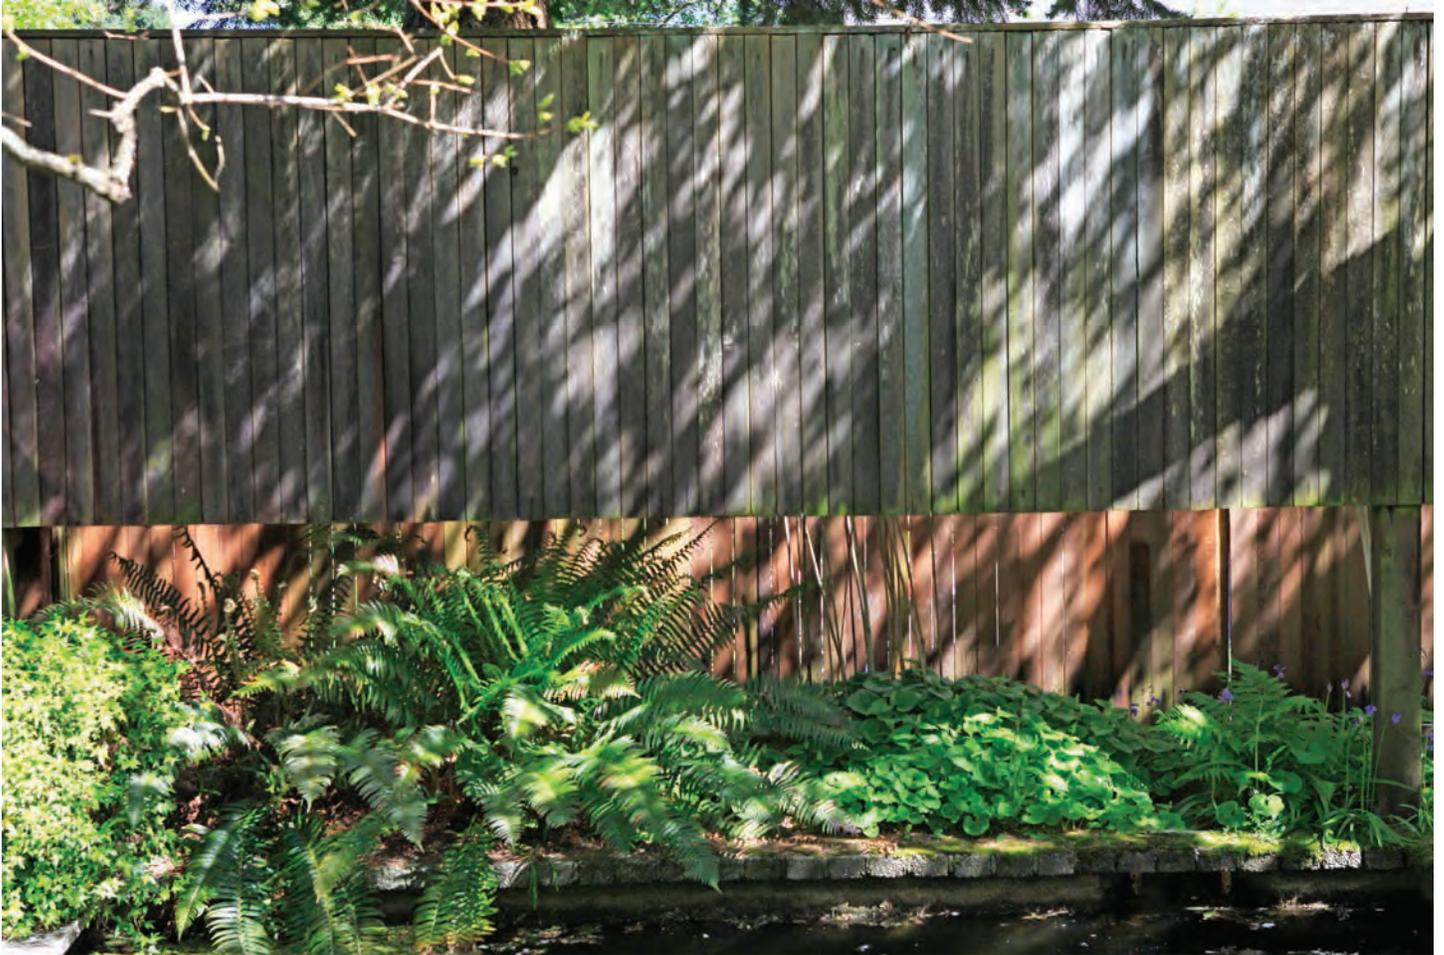
Existing Condition of wooden fence.

- Foundations should be reviewed by a Structural Engineer. Once condition is assessed, conservation recommendations can be finalized.
- To ensure the prolonged preservation of the new foundations, all landscaping should be separated from the foundations at grade by a course of gravel, decorative stones or other means, which will help prevent splash back and assist drainage. New vegetation may assist in concealing the newly exposed foundations, if desired, but should be adequately separated from the exterior building materials and be sympathetic to the existing significant garden. The appropriateness of any new landscaping should be reviewed in context of the rear garden.

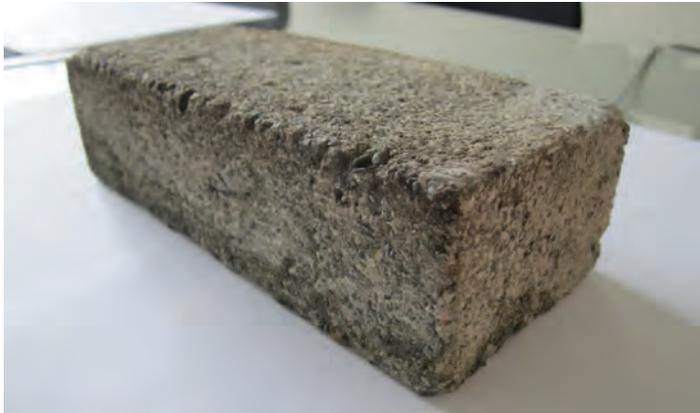
Concrete Brick Paver. Luxton 2015.

Given the extent to which the paved surfaces have deteriorated, complete removal, and reinstallation of salvaged and matching concrete bricks is recommended.
